# National Register of Historic Places Registration Form

1. Name of Property	
historic name <u>Hackman</u> , <u>Samuel E., Building</u>	
other names/site number Barner, A.L., Hardware  2 Location	Company Building

Hackman, Samuel E., Building Boone County, Missouri

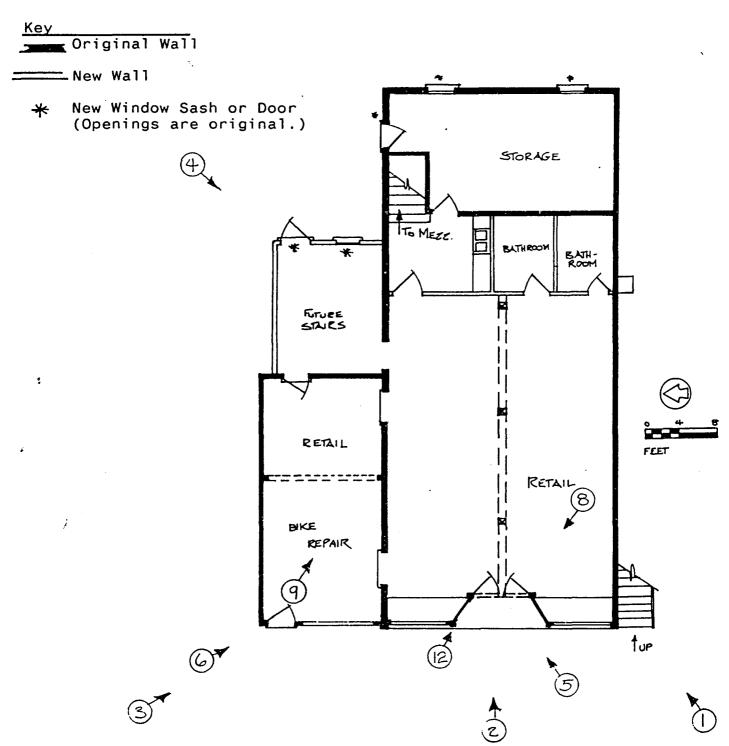
Figure One. Ground Floor Plan, with photo key.

The ground floor contains a large retail area, a smaller retail area and bike shop, a storeroom, and the new stair addition. (See Figures One and Two, floor plans.) The storeroom continues in its original function, and the large retail area for the bike shops occupies the former retail area of the hardware store. New restrooms between the sales floor and the storeroom constitute the only notable change to the room layout.

The ground floor contains a large retail area, a smaller retail area and bike shop, a storeroom, and the new stair addition. (See Figures One and Two, floor plans.) The storeroom continues in its original function, and the large retail area for the bike shops occupies the former retail area of the hardware store. New restrooms between the sales floor and the storeroom constitute the only notable change to the room layout.

See Figure One for an indication of camera angles.

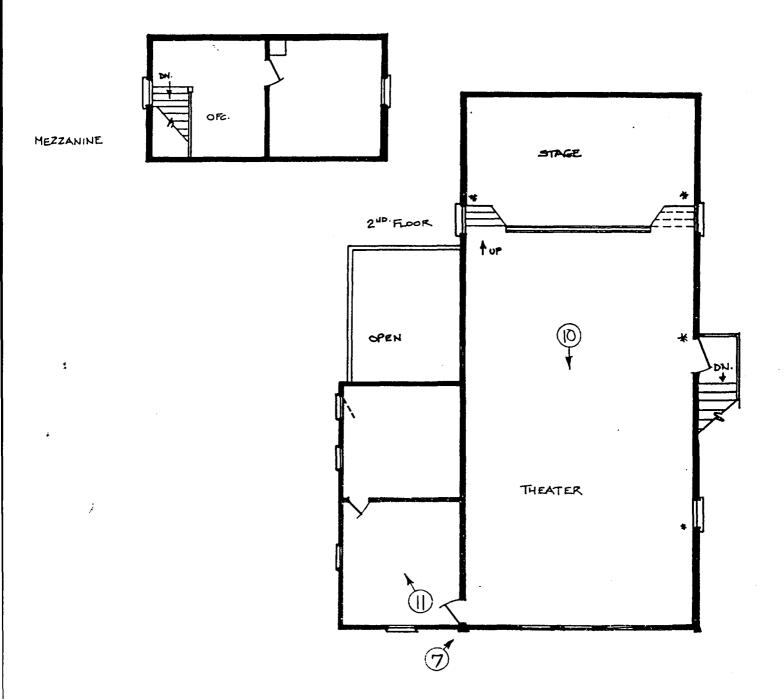
Figure Two. Mezzanine and Second Floor Plans, with photo key.

The second floor contains three original rooms and the new stair addition. There are two small rooms in the side wing; and one large theater in the main part of the building. The theater consists of a single open room with a raised stage at one end. The stage sits above the mezzanine rooms below, and though not original, appears to be very early. The stage was originally reached by a single short flight of steps that spanned the entire width of the room. A subsequent alteration covered most of that early stairway, leaving just two narrow runs, one on each side of the stage. The south stairway has since been removed as well.

The original second story rooms, though in poor condition, remain fargely intact. The ceiling plaster is gone, due to deterioration from a long term roof leak, but much of the early wall plaster remains in place. The side rooms have their original doors; a new door has been installed in the south doorway of the theater. The early doors in the theater have five horizontal panels, as does the door separating the two rooms of the mezzanine. Most of the woodwork is also intact, including wood floors, molded baseboards, and simple door and window trim. The doorways of the theater are surrounded by flat grooved trim set off with ornamental corner blocks.

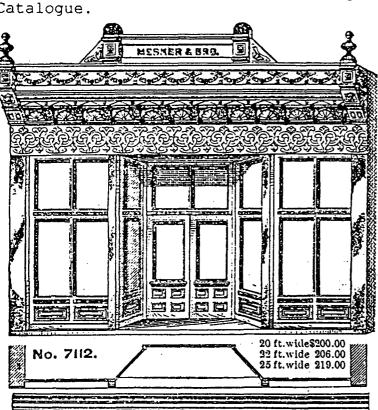
Figure Three. Mesker Brothers Catalogue Illustration From a ca. 1905 Catalogue.

The company's ca. 1905 catalogue boasted: "We claim for our Fronts, as chief advantages, economy in price, artistic and modern design, durability, perfect and practical construction." The claims appear to have been well-grounded, especially in the areas of durability and economy of price. The storefront on the Hackman Building shows very little wear after a century of use, and required only minor repairs during the recent rehabilitation. As to "economy in price," a check of the ca. 1905 catalogue shows that the front now on the Hackman building probably cost around \$300 when it was installed.

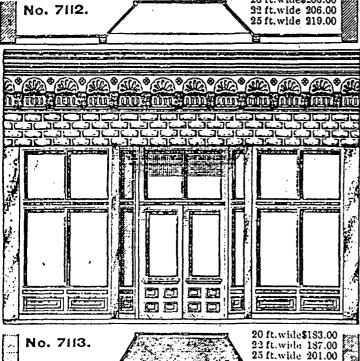
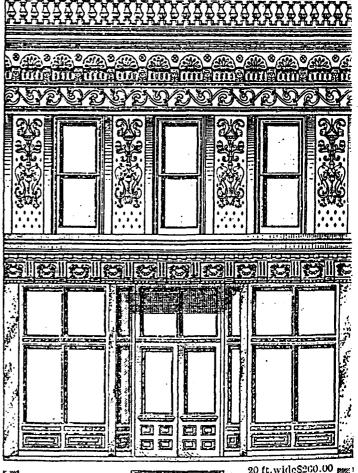
No. 7114.

To those contemplating the erection of buildings we furnish, free of charge, drawings for the Front to suit their requirements, upon receiving the size of frontage of lot, with such other information as may be necessary. For remodeling buildings where old fronts are to be torn out and new ones substituted, our styles and designs present such overwhelming advantages in cost and appearance as to defy competition.

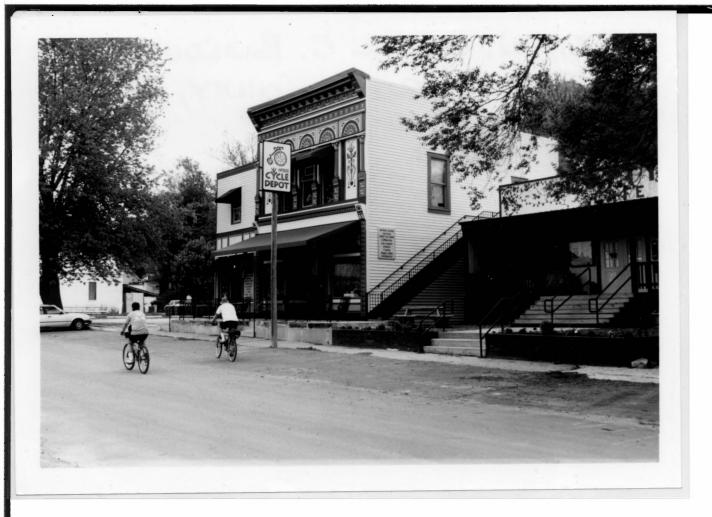
- 1. Southwest corner.
- 2. Facade (west elevation.)
- 3. Northwest corner.
- 4: Northeast corner (rear.)
- 5. Main storefront detail.
- 6. Side storefront detail.
- 7. Main cornice detail.
- 8. Interior, main store, ground floor.
- 9. Interior, side rooms, ground floor.
- 10. Interior, theater, second floor.
- 11. Interior, side rooms, second floor.
- 12. Mesker Brothers nameplate.
